Flightfax

ARMY AVIATION
RISK-MANAGEMENT
INFORMATION

JUNE 1999 ♦ VOL 27 ♦ NO 6

Tree strikes, you're out!

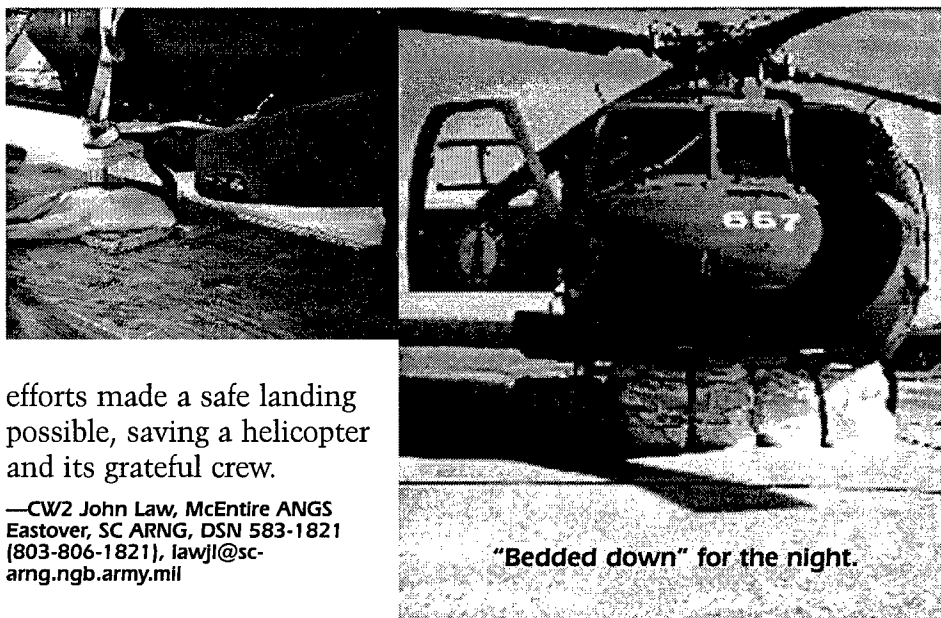
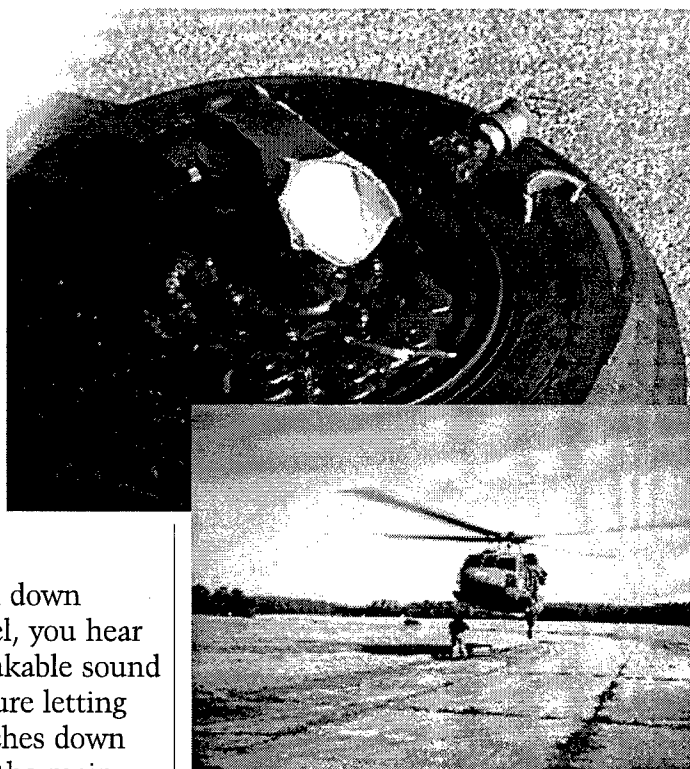
As the photos show, this one had a happy ending. Chalk it up to teamwork and true crew coordination that extended to include the ground crew. Their

efforts made a safe landing possible, saving a helicopter and its grateful crew.

main without endangering the crew and without inflicting additional damage to the aircraft? You solicit input from the copilot and the crew chief after telling them you intend to land on a slope. You're concerned about two things, both centered on what remains of the right main strut: What will prevent it from pivoting about its upper mount, and how far will the strut sink into the sod on a slope? Either possibility could result in blade-ground contact with obvious consequences.
